# Manhole Inspection Summary

Manhole # S43C2\_005MH

Insp Date: **12/12/07 2:09 PM**

**Location** Address: **3800 West Bay Ave** Cross Street: **Washburn Ave.**

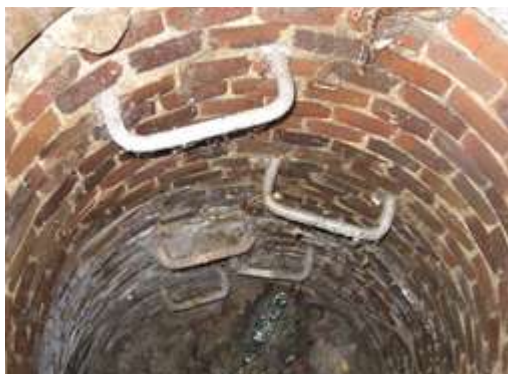
Steps

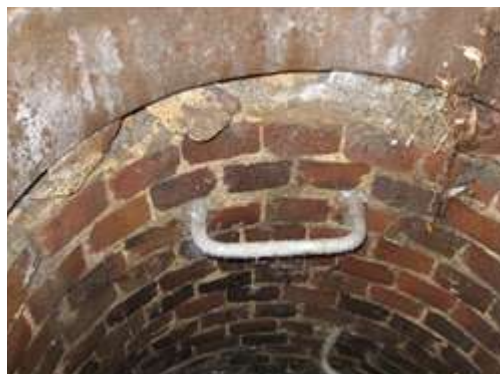
Defect 1

**Chimney / Frame Adjustment** ☒ Exists Material: **Brick** ☐ Parged Height: **0** (in.)  
Condition: ☐ Sound ☐ Cracked ☐ Root Intrusion ☒ **Loose Brick** ☐ Deteriorated  
Infiltration: ☐ None ☐ Joint ☐ Cracks ☒ **Mortar** ☐ Roots ☒ **Wall**

**Corbel** Material: **Brick** ☐ Parged Type: **Concentric/Eccentric**  
Condition: ☐ Sound ☐ Cracked ☐ Root Intrusion ☒ **Loose Brick** ☐ Deteriorated  
Infiltration: ☒ None ☐ Joint ☐ Cracks ☐ Mortar ☐ Roots ☐ Wall

Loose bricks

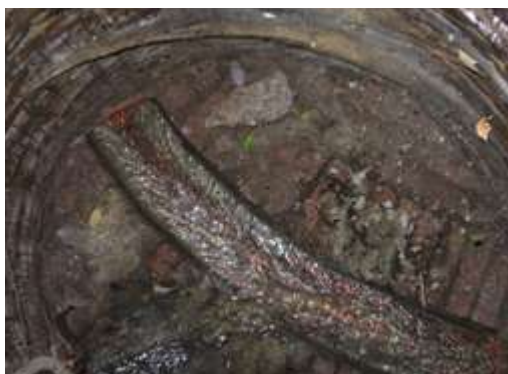
Defect 2

Debris

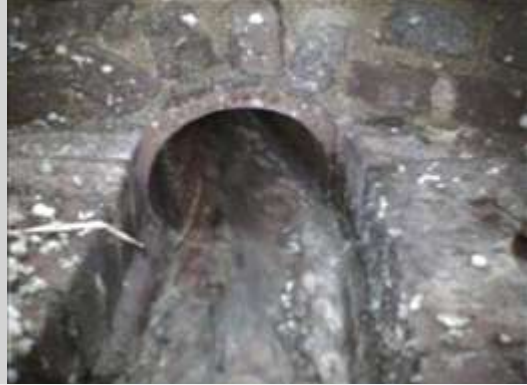
12 O'Clock Outflow

8 in. Circular Gravity Sewer  
Pipe Out @ 12 O'Clock

Pipe Height: **9.6** (in.) Rod and Bar (Angled)  
Pipe Material: **Clay** ☐ Pipe Lined  
Invert Depth: **9.73** (ft.) Flow Characteristics: **Fast**  
Deposits: ☒ None ☐ Mud ☐ Sludge ☐ Debris ☐ Grease  
Silt Depth: (in.) Deposits Extent:  
Infiltration: **None** Pipe Seal Cond: **Sound**

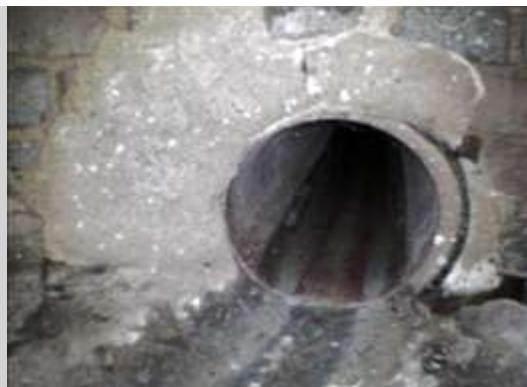
4 O'Clock Inflow

8 in. Circular Gravity Sewer  
Pipe In @ 4 O'Clock

Pipe Height: **10.8** (in.) Rod and Bar (Angled)  
Pipe Material: **Clay** ☐ Pipe Lined  
Invert Depth: **9.26** (ft.) Flow Characteristics: **Fast**  
Deposits: ☒ None ☐ Mud ☐ Sludge ☐ Debris ☐ Grease  
Silt Depth: (in.) Deposits Extent:  
Infiltration: **None** Pipe Seal Cond: **Sound**

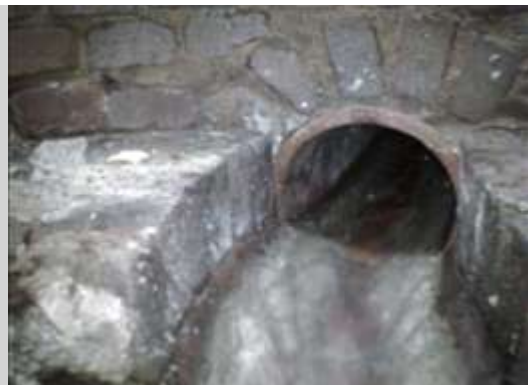
7 O'Clock Inflow

Pipe In @ 7 O'Clock

Pipe Height: **9.6** (in.) Rod and Bar (Angled)

Infiltration: **None** Pipe Seal Cond: **Sound**
